Coastal protection work using Geotubes

Region	Kerala (India)
Type	Coastal Protection
Client	Irrigation Deptt, Ernakulam
Execution of the work	Renesco India Private Limited
Construction Period	2018 – 2020

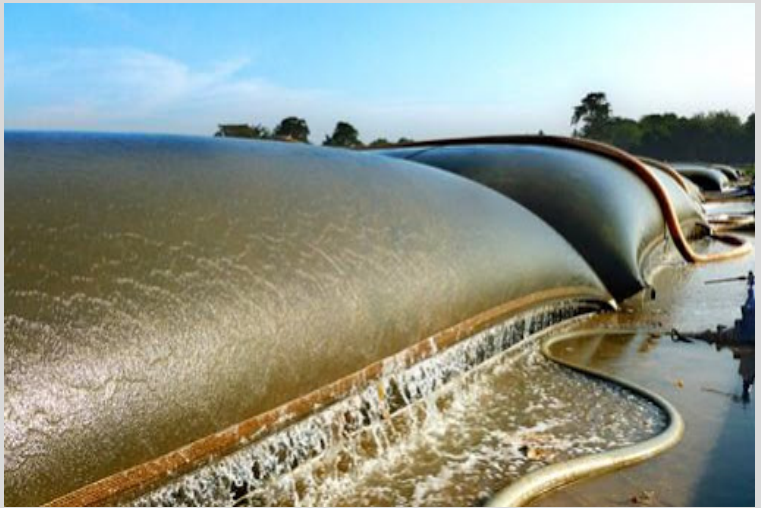
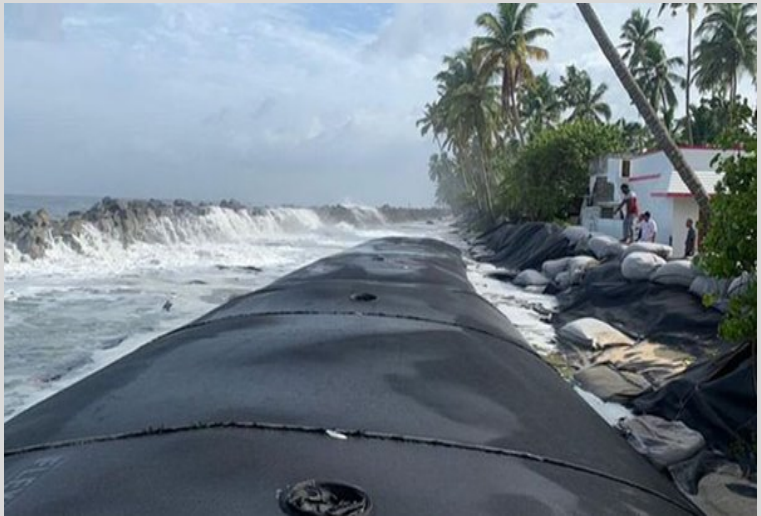
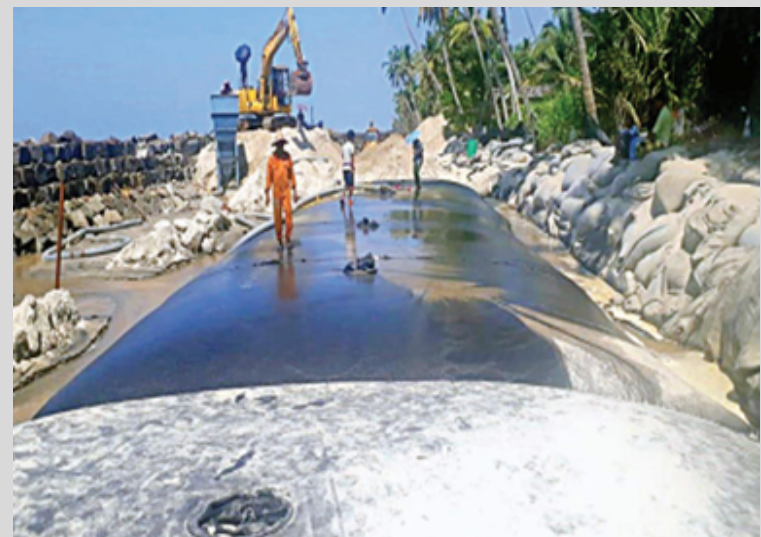
The project involves use of Polypropylene based high strength woven fabric (Geotube). The tube has high strength and permeable fabric which is able to hold back material while water flows through. Coastal stretch along Chellanam, Kochi (southern part of India) was severely eroded during 2018 monsoon flood. In order to reduce the coastal erosion, sand filled geotube work started. Geotubes are large tubes filled with sand slurry mix. The mix usually comes from dredged sand from the nearby sea area

- Demolishing and rearranging the existing damaged sea wall and dumping in position (to form as 1:3 slope, not to be packed) with Granite stones 300kg to 500kg
- Supply of Geo textile tube of length 25 m, circumference of 15.70 m to provide an inflated height of 2.5 m or above after filling using dredged sea sand - fill or slurry.
- Providing woven Geo textile layer to act as scour apron beneath the bottom layer Geotubes.
- Installation of Geotubes - Installation of 3 Nos of Geotubes, 2 Nos at bottom and one at top of length 25m at site Hydraulic filling of Geotextile tubes using excavated sand with the help of dredged pump.
